INDOOR AIR QUALITY ASSESSMENT

**Auburn High School
99 Auburn Street
Auburn, Massachusetts**

Prepared by:
Massachusetts Department of Public Health
Bureau of Environmental Health Assessment
Emergency Response/Indoor Air Quality Program
May, 2002

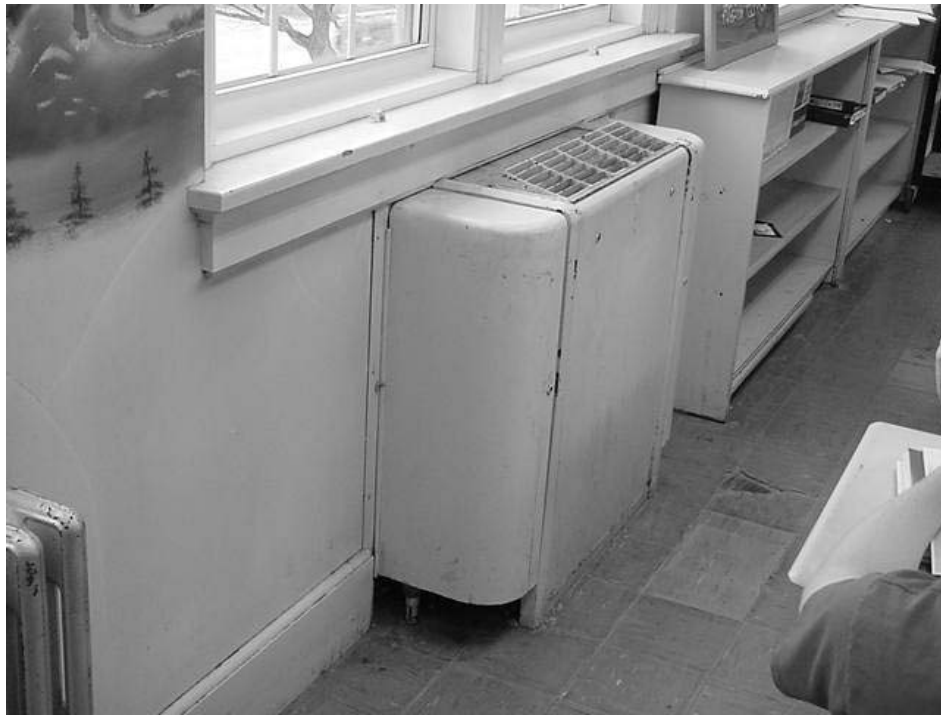
Picture 1

Fresh air in classrooms is supplied by a unit ventilator (univent) system (see Picture 1). Univents draw air from outdoors through a fresh air intake located on the exterior walls of the building and return air through an air intake located at the base of each unit ([see Figure 1](#)). Fresh air and return air are mixed, filtered, heated and provided to classrooms through a fresh air diffuser located in the top of the unit. Univents were found deactivated in a number of classrooms (see Tables).

Univents in the original building, as well as in the 1953 and 1973 wings, appear to be original equipment, which would make them approximately thirty to fifty years old. None of the univents appeared to be operable in the original building. A number of univents in the 1953 and 1973 wings were deactivated or not operating. Univents in these wings do not run continuously but are activated by thermostats once room temperatures drop below a set level. When the room temperature exceeds the thermostat setting, univents deactivate. Without mechanical ventilation running continuously, fresh air cannot be introduced into classrooms on a consistent basis.

Example of Classroom Univent

4. Remove all blockages from univents and exhaust vents to ensure adequate airflow. Clean out interiors of univents regularly.
5. Implement the corrective actions recommended concerning remediation of bird wastes. Remove bird's nests from the exhaust vents. Repair these exhaust fans to working order. Examine the feasibility of installing fans in a configuration to reduce vandalism of this equipment.

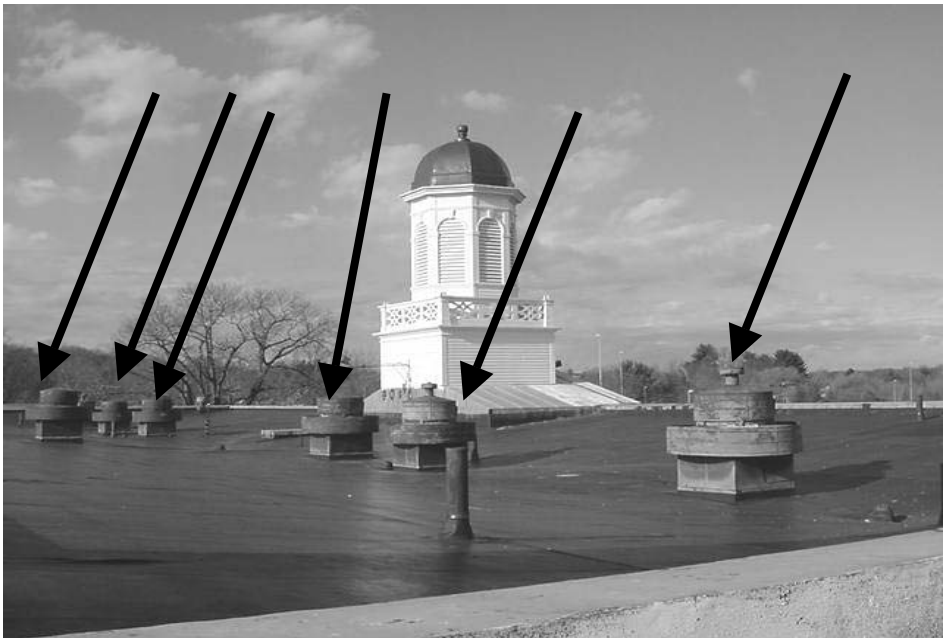
Picture 2

The mechanical exhaust ventilation system consists of ceiling and wall-mounted exhaust vents, some of which are located in ungrated holes located at floor level. These vents are connected to exhaust fans on the roof (see Picture 2). An examination of these exhaust vents found more than half of the exhaust vent motors either deactivated or barely drawing air (see Table 8). Exhaust vents on the side of the building were also found deactivated (see Picture 3). Bird's nests were observed inside these vents which appear to service the audiovisual room, auditorium and TV studio. Tables, chairs, boxes and other items obstructed a number of exhaust vents. Some exhaust vents are equipped with pull chains that control a flue that adjusts airflow out of the ventilation shaft. A number of these control mechanisms (i.e., pull chains and flues) were missing or not operable. A weak draw of air at best was detected in classrooms throughout the building (see Tables), which can indicate that the exhaust ventilation was turned off, rooftop motors were not functioning, or control mechanisms such as flues were shut.

Rooftop Exhaust Vents

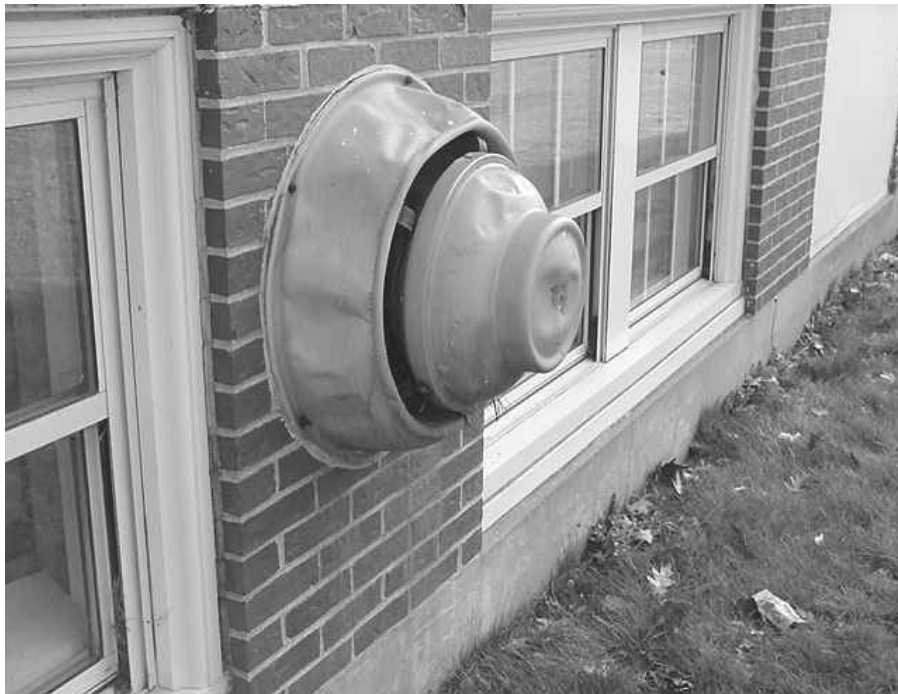
Picture 3

Deactivated Exhaust Vent in West Wall of Building

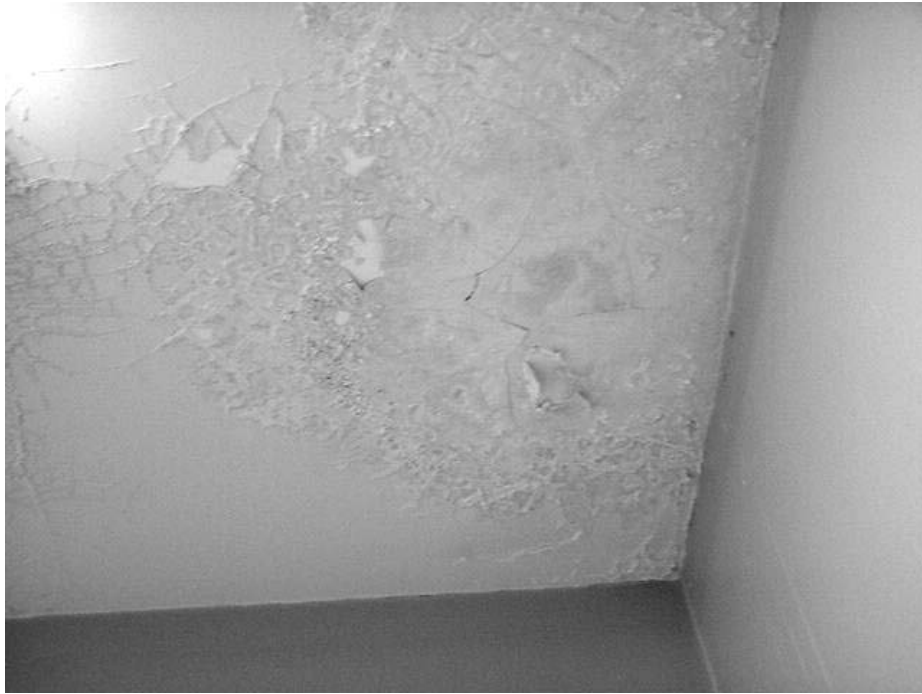
Picture 4

A number of interior areas of the building had signs of water damage. Water-damaged wall/ceiling plaster was noted throughout the building (see Picture 4). Water-damaged wall plaster was frequently noted above windows. Water-damaged ceiling tiles were noted in a number of classrooms, which are evidence of historic roof or plumbing leaks. Water-damaged building materials can serve as mold growth media, and should be replaced after a water leak is discovered.

Water-Damaged Wall/Ceiling Plaster

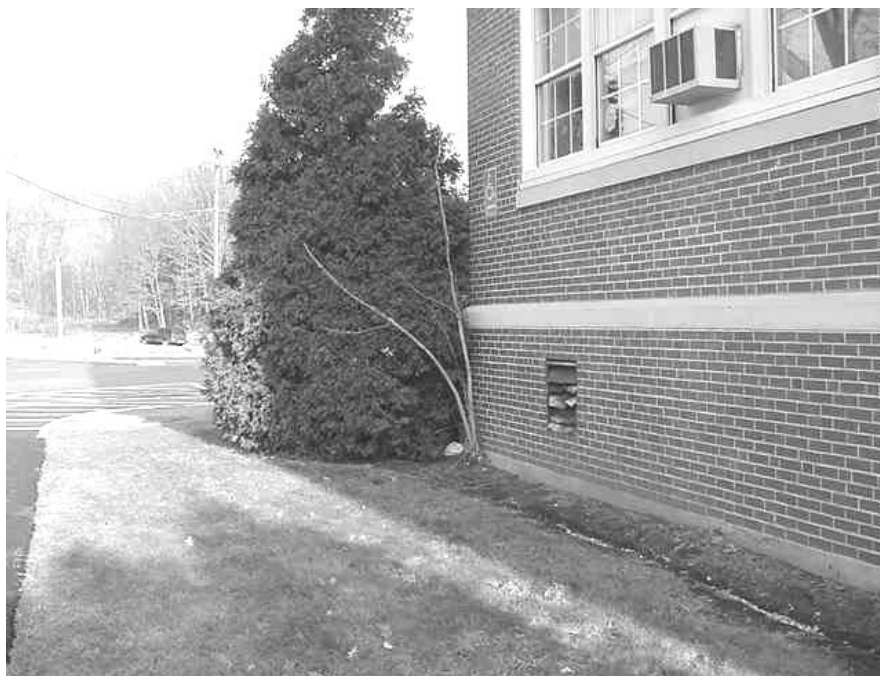
Picture 5

Along the perimeter of the building, shrubbery and flowering plants were noted in close proximity to univent fresh air intakes or in contact with exterior walls (see Picture

5). Shrubbery and flowering plants can be a source of mold and pollen and should be placed and/or maintained to ensure that fresh air intakes remain clear of obstructions to prevent the entrainment of dirt, pollen or mold into the building.

Shrubbery and Flowering Plants in Contact with Exterior Walls

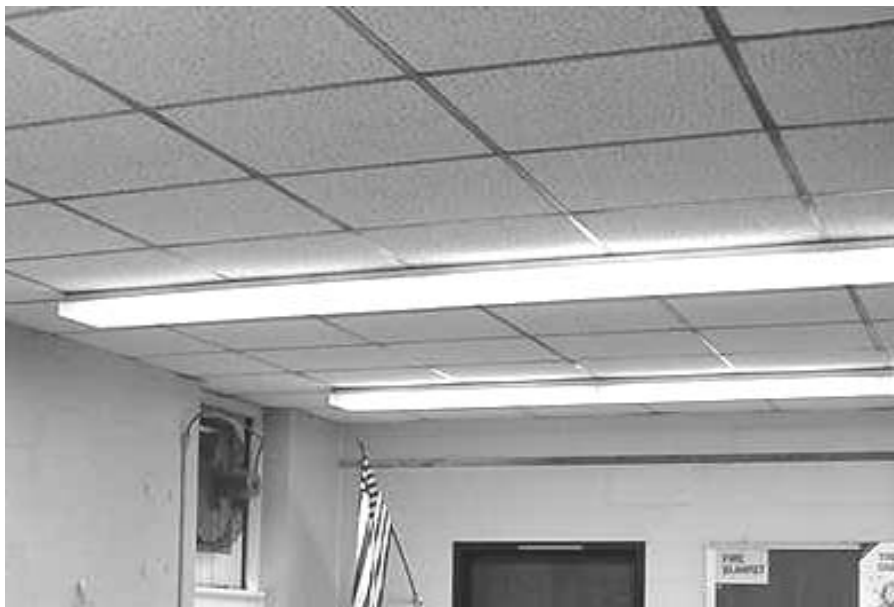
Picture 6

Experiments in science labs that produced significant smoke were noted. Exhaust fans to remove smoke and other odors are installed in science classroom windows (see Picture 6). These fans are reportedly not used because they produce a loud noise when activated. Fans should be activated prior to beginning smoke/odor-producing experiments.

Exhaust Fan in Chemistry Lab

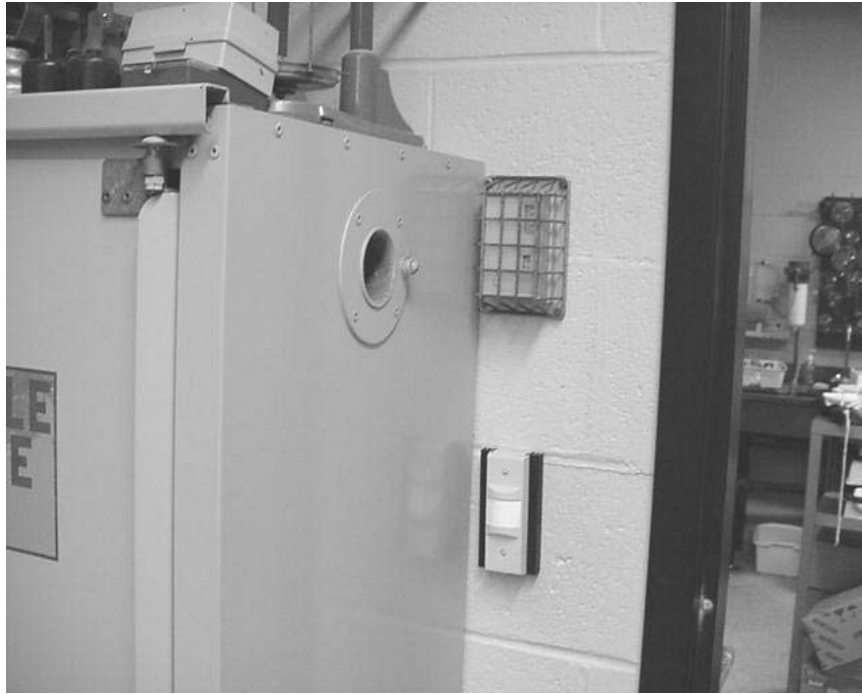
Picture 7

1. The exhaust vent fan was not operating at the time of the assessment. Exhaust ventilation is necessary to remove off-gassing from chemicals in storage from the interior of the building.
2. Of note is the condition of the flameproof cabinet in the chemical storeroom. A selection of flammable materials (see Table 9) were stored within this cabinet as well as in the storeroom, outside of the cabinet. The bung-hole covers were removed from the flameproof cabinets (see Picture 7). The National Fire Prevention Association (NFPA) does not require venting in flammable storage

cabinets, however, if venting is done, it must be vented directly outdoors and in a manner not to compromise the specific performance of the cabinet (NFPA, 1996). With this breach, it would not be expected that this cabinet would perform as designed in the case of a fire.

Flameproof Cabinet with Open Bung Hole

1. Replace bunghole caps on all flameproof cabinets throughout the building.
Remove vent hose and reseal wall/window penetrations.
2. Examine each univent for function. Survey classrooms for univent function to ascertain if an adequate air supply exists for each room. Consider consulting a heating, ventilation and air conditioning (HVAC) engineer concerning the calibration of univent fresh air control dampers school-wide.

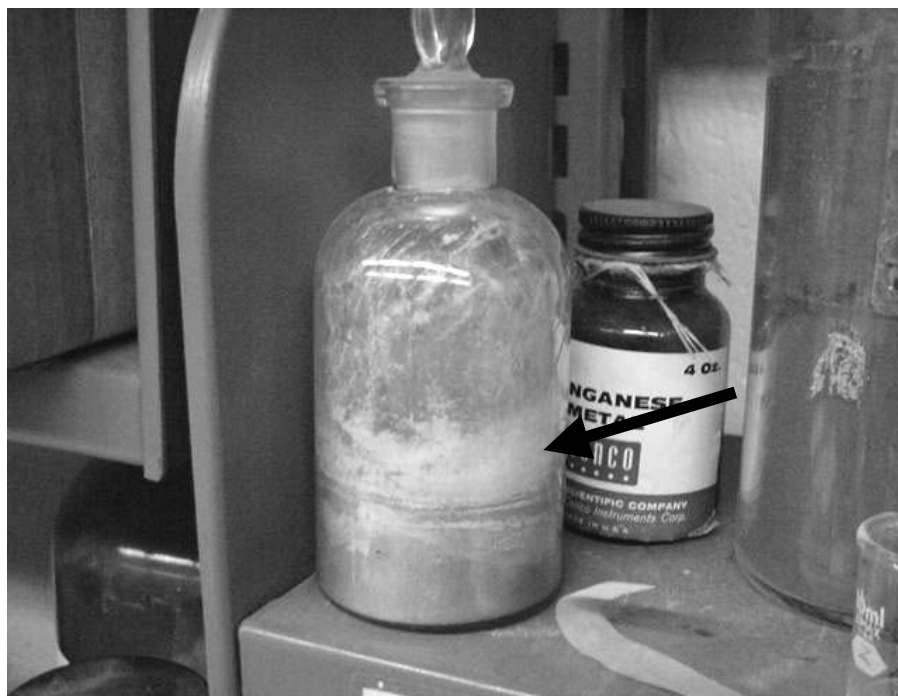
Picture 8

3. An unlabelled container of elemental mercury, in a quantity estimated to weigh 10 lbs., was stored on an open shelf (see Picture 8).
4. Two corroded containers of phosphorous were stored on an open shelf (see Picture 9).

Unlabelled Container of Elemental Mercury (Approximately 10 Lbs.), Stored on an Open Shelf

16. Have an experienced hazardous waste removal consultant evaluate the chemical storeroom for proper chemical storage and recommendations for removal of hazardous waste.

17. Have a chemical inventory done in all storage areas and classrooms. Discard hazardous materials or empty containers of hazardous materials in a manner consistent with environmental statutes and regulations. Follow proper procedures for storing and securing hazardous materials. Obtain Material Safety Data Sheets (MSDS') for chemicals from manufacturers or suppliers.

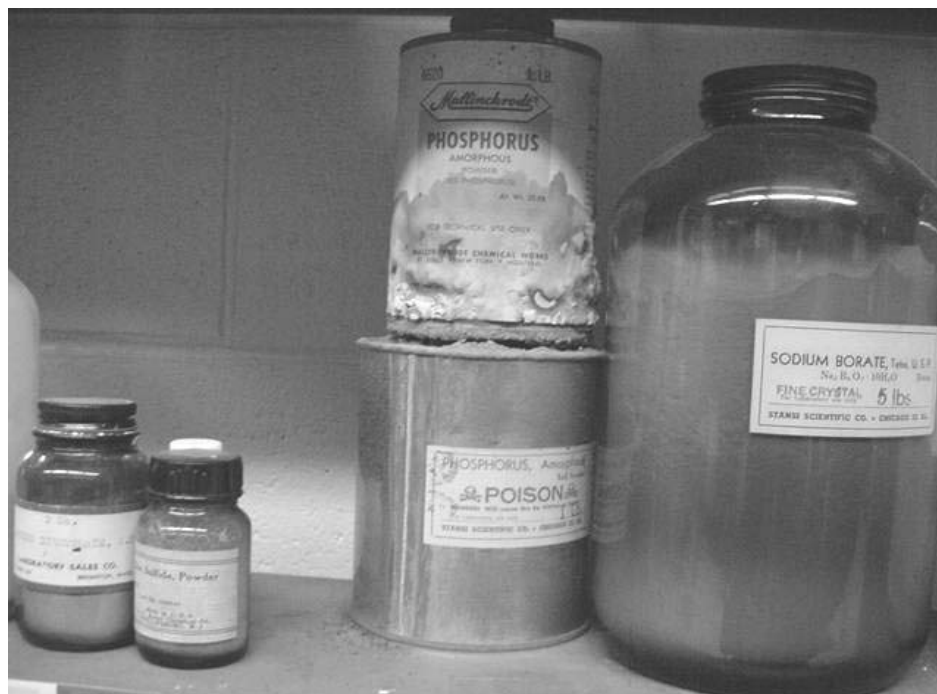
Picture 9

Two Corroded Containers of Phosphorous Stored on an Open Shelf

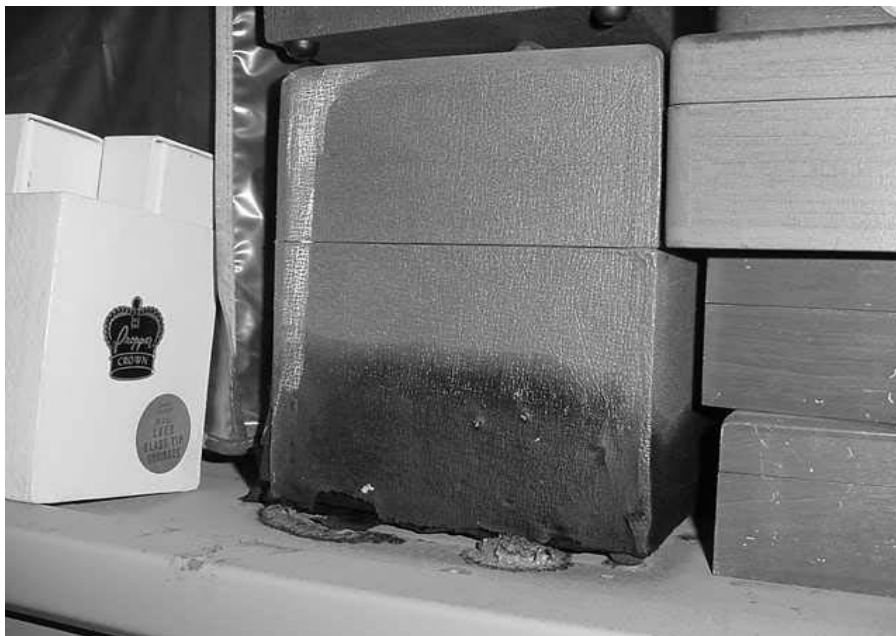
Picture 10

5. A box that appears to be chemically damaged exists on top of a cabinet (see Picture 10).
6. A container of carbon tetrachloride exists on a cabinet. Plastic sheeting on top of the cabinet, in contact with this container, is adhered to the container, indicating possible off-gassing interaction with the plastic (see Picture 11).

A Box that Appears to be Chemically Damaged

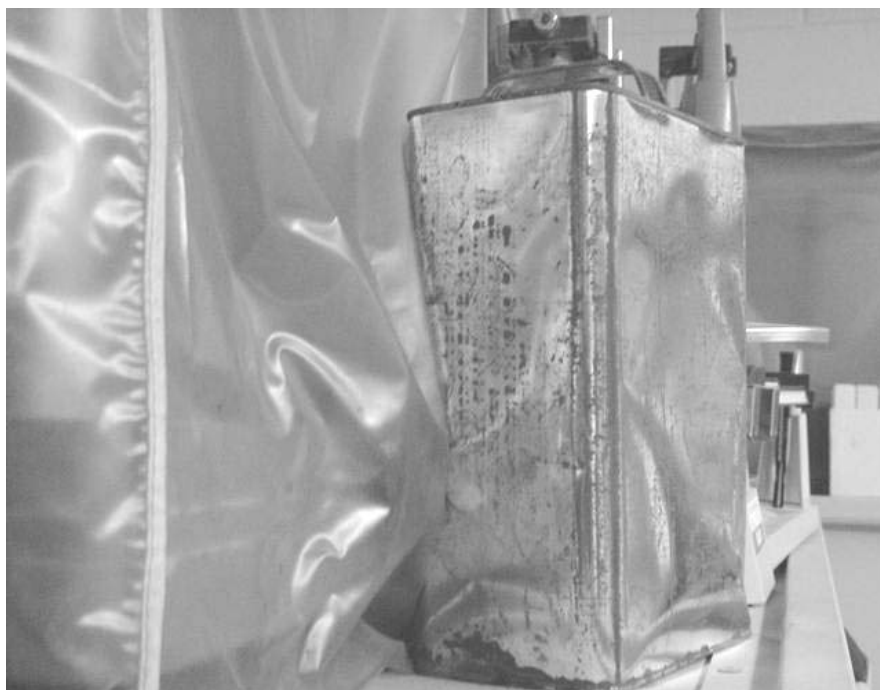
Picture 11

A Container of Carbon Tetrachloride Adhered to Plastic Sheetting

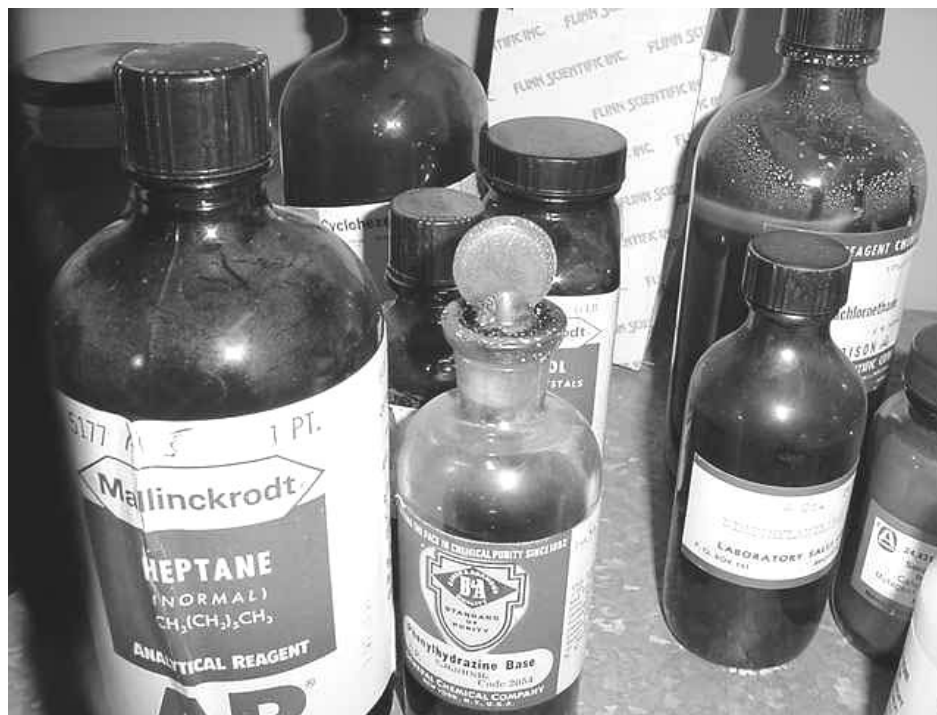
Picture 12

7. Chemicals in the storeroom are stored on shelves without any barriers to prevent bottles from falling.
8. A container of leaking phenylhydrazine base was found in one of the flameproof cabinets (see Picture 12). Phenylhydrazine is considered an extremely hazardous material that requires special handling.

Container of Leaking Phenylhydrazine Base

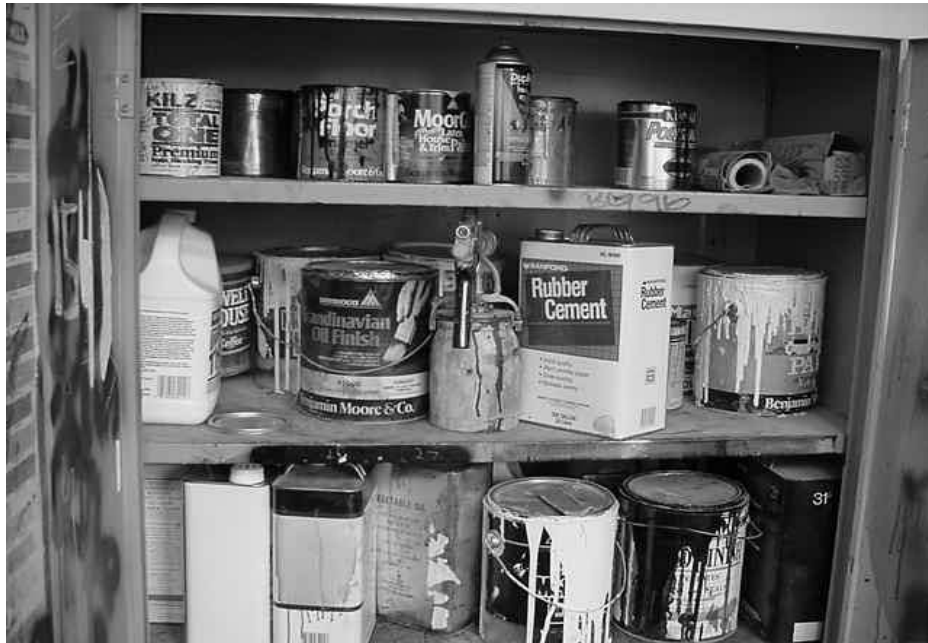
Picture 13

A number of materials are also stored in a plain metal cabinet in the wood shop (see Picture 13). These products are flammable and should be stored in a cabinet which meets the criteria set forth by the NFPA (NFPA, 1996). The woodshop has local exhaust ventilation for wood cutting/sanding machines. A wood dust collector exists in this room. This wood dust collector is not ducted to the outdoors, but is allowed to exhaust into the room (see Picture 14). Since the wood dust collector is not designed to filter small diameter particles, the use of this machine without ducting outdoors may aerosolize wood dust to allow it to be more readily inhaled. Excessive amounts of wood dust on flat surfaces indicate that wood dust aerosolization is occurring. Wood dust can be irritating to the eyes, nose, throat and respiratory system. A ceiling-mounted fan heater also exists in this room. Under certain conditions, wood dust is a fire hazard.

Materials Stored in a Plain Metal Cabinet in the Wood Shop

19. Properly store chemicals and cleaning products.
20. Seal holes, repair wall cracks and replace missing ceiling tiles to prevent egress of odors, fumes and vapors between rooms and floors.

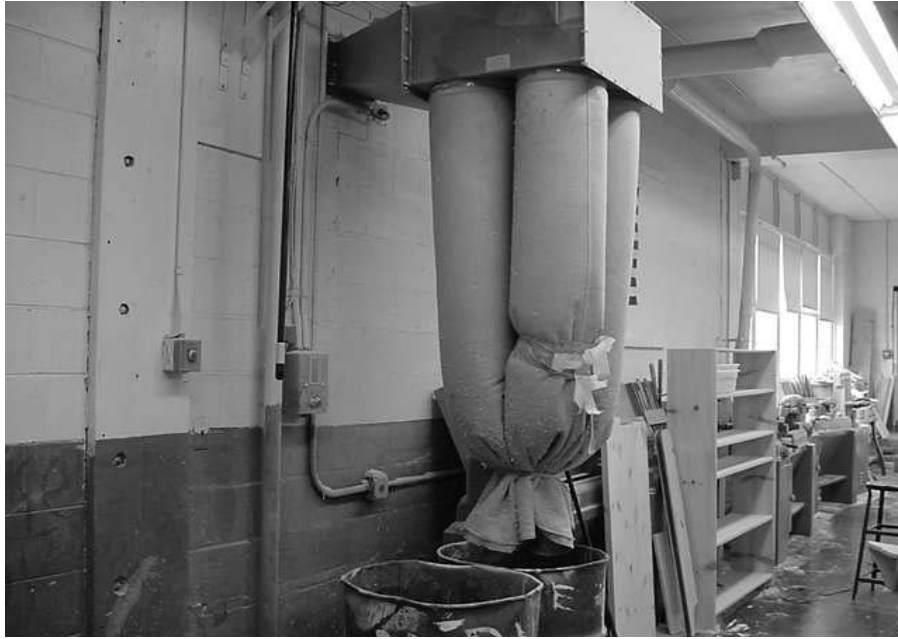
Picture 14

Wood Dust Collector - Not Ducted to the Outdoors - Is Allowed to Exhaust into the Room

1. Based on the age, physical deterioration and availability of parts of the HVAC system, the BEHA strongly recommends that an HVAC engineering firm fully evaluate the ventilation system. This evaluation must include an examination of the integrity of fiberglass lined ductwork as well as the modifications of the former lab area (A-321, A 322 & A-323).
2. Continue to isolate and repair water leaks. Repair/replace any water-damaged ceiling tiles, plaster and/or other damaged building materials. Examine above and around these areas for mold growth. Disinfect areas of water leaks with an appropriate antimicrobial. Building occupants should report any roof leaks or other signs of water penetration to school maintenance staff for prompt remediation.
3. Examine the feasibility of providing exhaust ventilation for the wood shop dust collector.

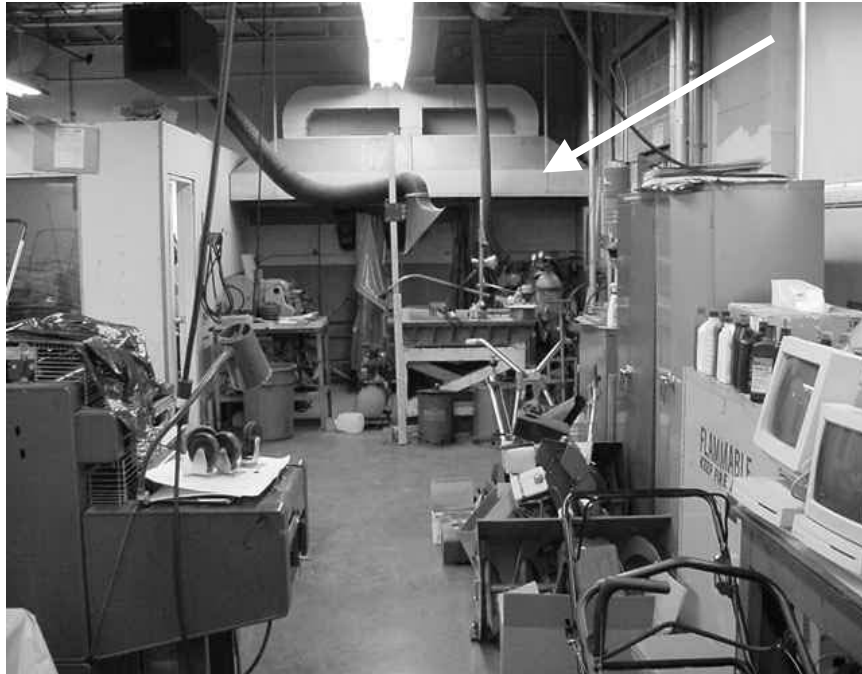
Picture 15

The print shop has a printing machine that does not have a dedicated local exhaust ventilation system. An exhaust hood exists in the corner of this area, which was originally used for venting metalworking in this room (see Picture 15). Inside the print shop are a number of printers that use volatile organic compound (VOC) containing materials. No local dedicated exhaust ventilation exists for any of the printers. Inks, washes and hand cleaners used in printing can contain VOCs, which can be irritating to the eyes, nose, throat and respiratory system. Products containing VOCs must be used with adequate exhaust ventilation to prevent exposure.

Metal Fume Exhaust Hood in Print Shop

13. Consider relocating the printers in the print shop underneath the metal fume hood to provide exhaust ventilation. If metal fume hood is not operational, repair.

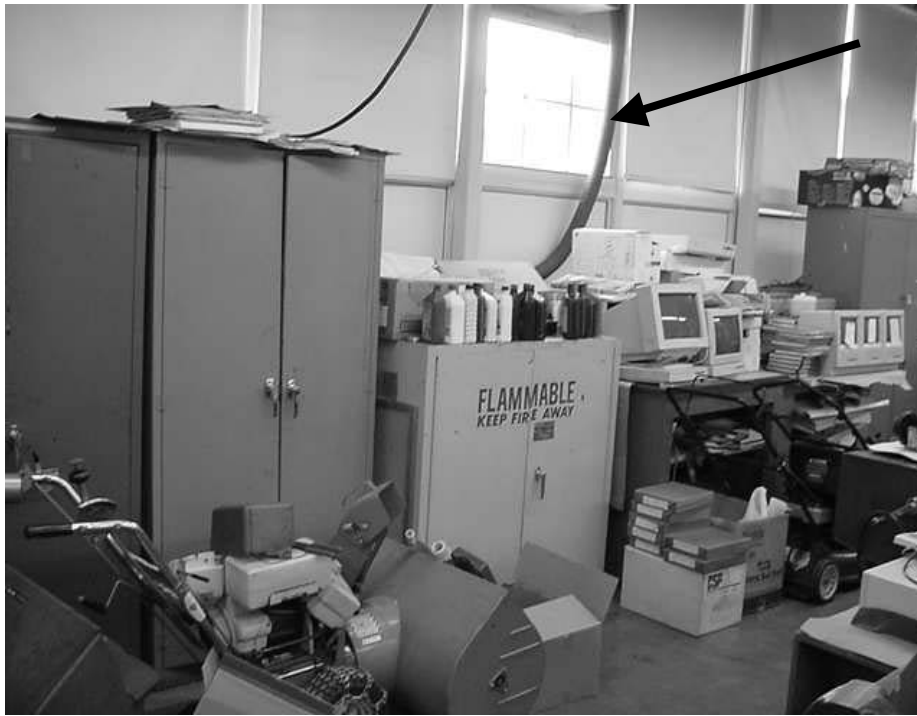
Picture 16

Also of concern is the connection of a flameproof cabinet to a duct on the exterior wall of the building (see Pictures 16 and 16A). As previously mentioned, the NFPA recommends that flammable storage cabinets be constructed in a manner to prevent fire from coming in contact with stored chemicals. In addition, it is recommended that if a flammables storage cabinet is connected to a vent system, the vent system should not be constructed in a manner to provide an oxygen source to the interior of the cabinet. It must be vented directly outdoors and in a manner not to compromise the specific performance of the cabinet (NFPA, 1996).

Flameproof Cabinet - Duct Connected to the Exterior Wall of the Building

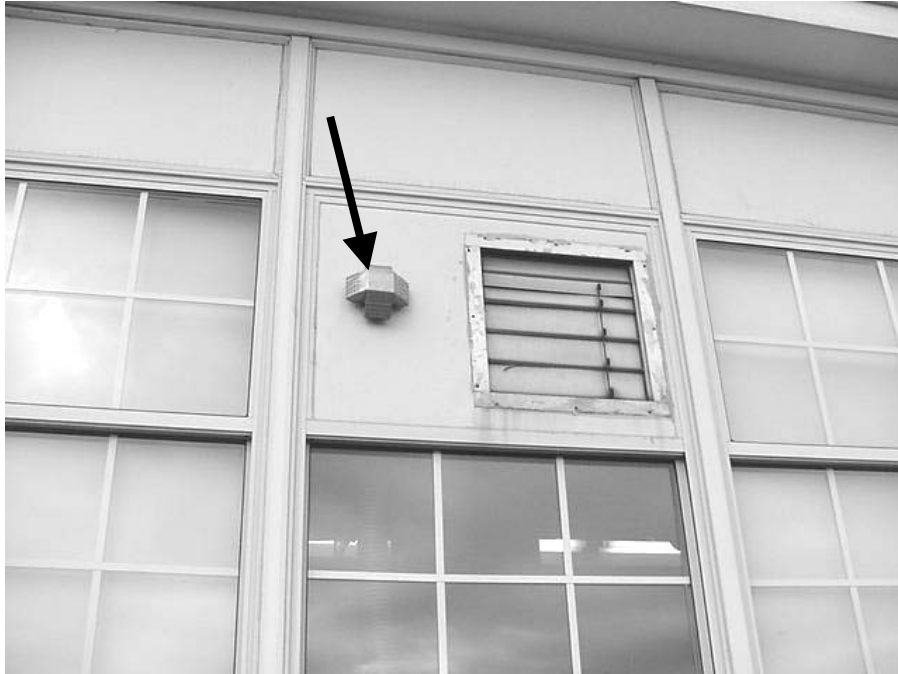
Picture 16A

Terminus of Vent for Print Shop Flame-Proof Cabinet

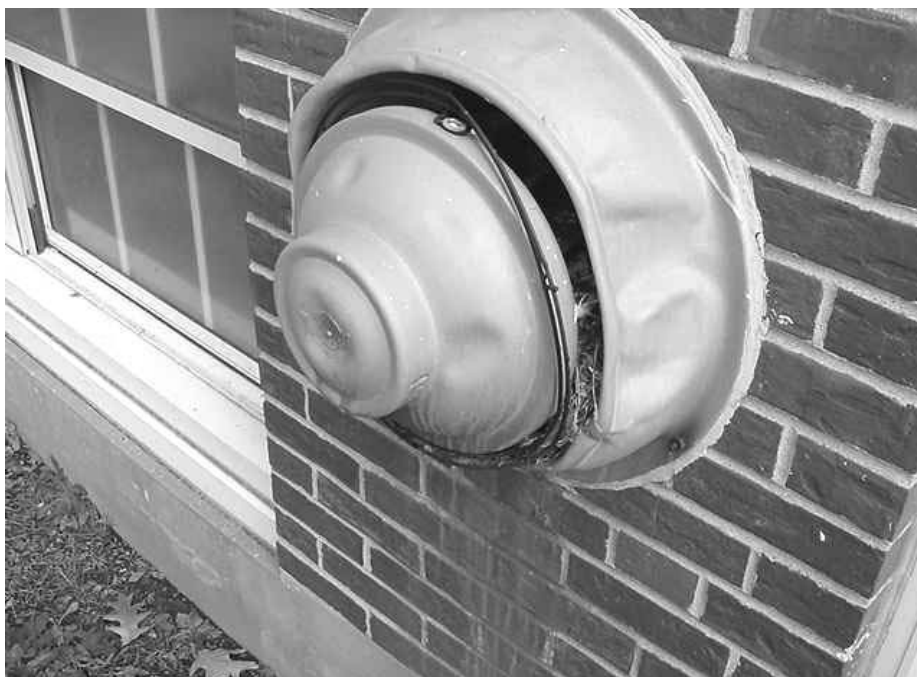
Picture 17

Bird wastes were observed inside exhaust vents along the west exterior wall of the building (see Picture 17). Under these conditions, it is possible for molds and allergenic materials associated with bird wastes and feathers to be entrained by the air intake and distributed into the classroom via the univent. Bird wastes in a building raise three concerns: 1) diseases that may be caused by exposure to bird wastes, 2) the need for clean-up of bird waste and 3) appropriate disinfection.

Certain molds are associated with bird waste and are of concern for immune-compromised individuals. Other diseases of the respiratory tract may also result from chronic exposure to bird waste. Exposure to bird wastes are thought to be associated with the development of hypersensitivity pneumonitis in some individuals. Psittacosis (bird fancier's disease) is another condition closely associated with exposure to bird wastes in either the occupational or bird raising setting. While immune-compromised individuals have an increased risk of health impacts following exposure to the materials in bird wastes, these impacts may also occur in healthy individuals exposed to these materials.

Bird Wastes Inside Exhaust Vent, Along the West Exterior Wall of the Building

The methods to be employed in clean up of a bird waste problem depend on the amount of waste and the types of materials contaminated. The MDPH has been involved in several indoor air investigations where bird waste has accumulated within ventilation ductwork (MDPH, 1999). Accumulation of bird wastes have required the clean-up of such buildings by a professional cleaning contractor. In less severe cases, the cleaning of the contaminated material with a solution of sodium hypochlorite has been an effective disinfectant (CDC, 1998). Disinfection of non-porous materials can be readily accomplished with this material. Porous materials contaminated with bird waste should be examined by a professional restoration contractor to determine if the material is salvageable. Where a porous material has been colonized with mold, it is recommended that the material be discarded (ACGIH, 1989).

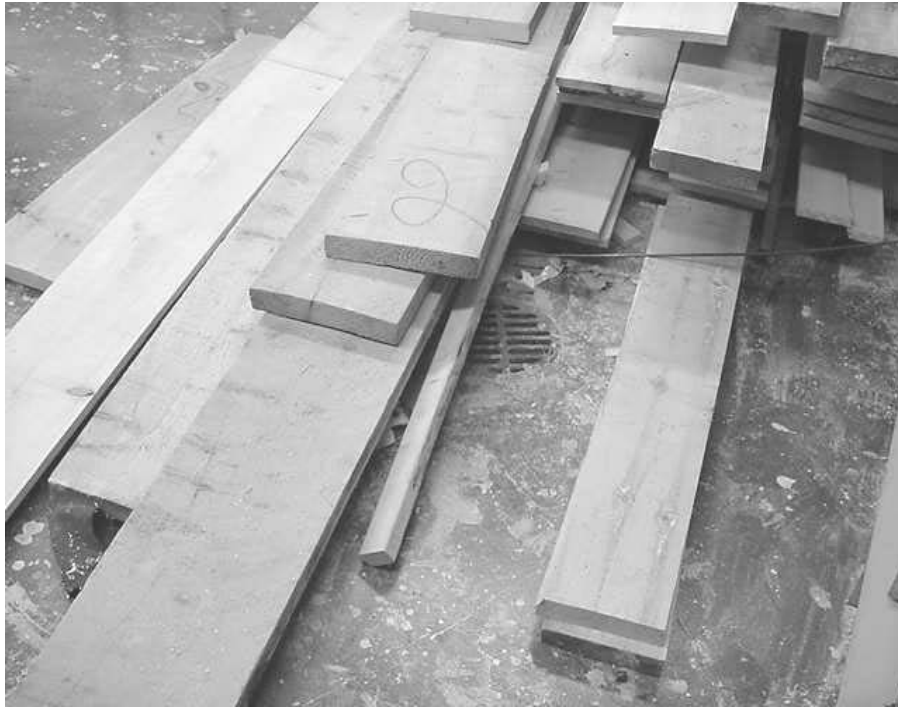
Picture 18

Floor Drain in Wood Shop
